Urgent Field Safety Notice

SynchroMed® II Implantable Drug Infusion Pump

Design Change of Model Numbers 8637-20 and 8637-40

Medtronic reference: FA794

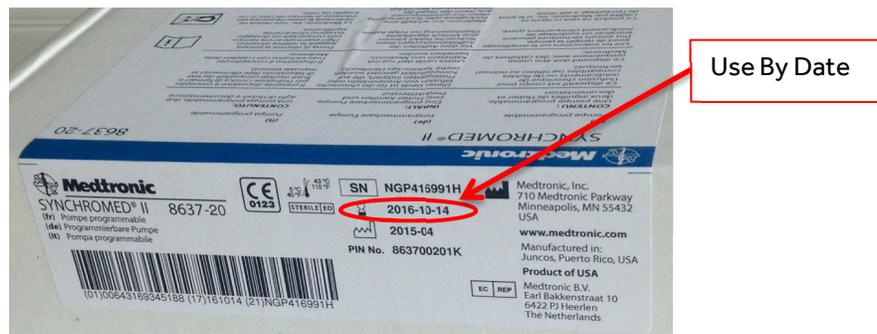
Pump Identification: in Europe, Middle East, Africa, Latin America and India any pump with a Use By Date **on or before** 2018-12-31 was manufactured **prior to** design change. An image of the Shelf Box Side Label of the SynchroMed II is shown below.
