Urgent Field Safety Notice Update SynchroMed® II Implantable Drug Infusion Pump

Update to 2011 Notification, for Pumps Manufactured through June 2011

April 2017

Medtronic reference: FA760

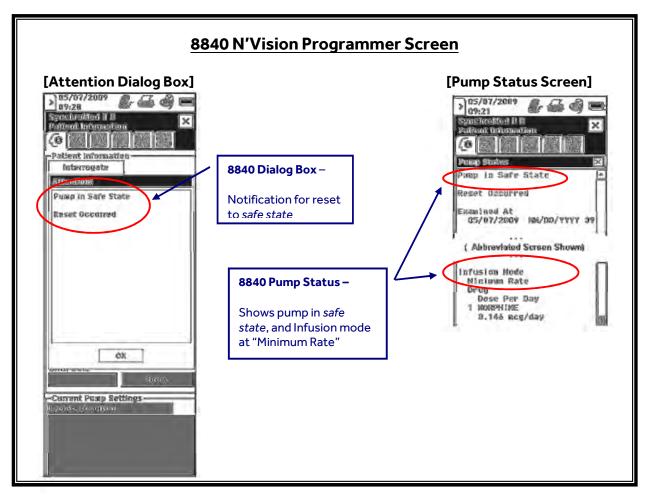
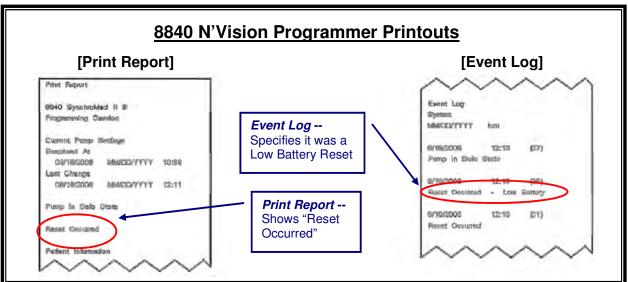
Safe state does not mean a clinically safe rate of infusion. The minimum rate mode in effect during a pump safe state is non-therapeutic and can result in loss of drug effect and/or drug withdrawal.

<u>If Low Battery Reset (critical alarm) Occurs:</u> **Replacement surgery should be scheduled as soon as possible.** Although you may be able to reprogram the pump, the issue may reoccur *at any time*. Alternative medical management should be considered if appropriate.

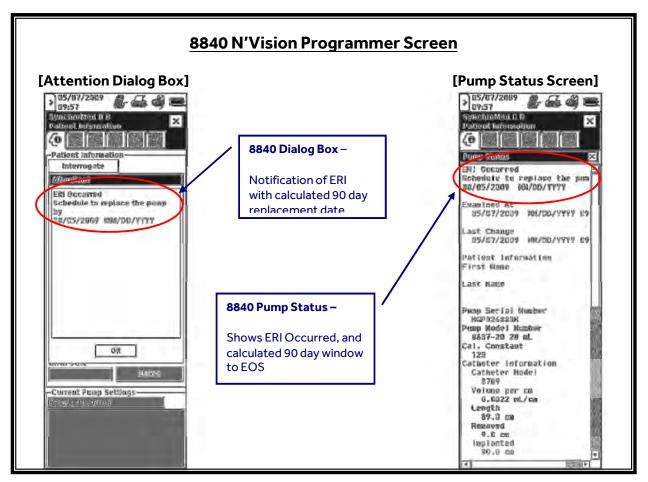
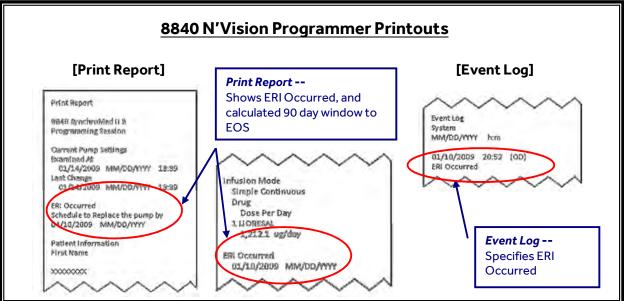
The minimum timeframe of 90 days between ERI and EOS may be reduced in an affected pump; therefore the scheduled replacement date displayed on the *Print Report* may not be accurate.

If premature Elective Replacement Indicator (non-critical alarm) or End of Service (critical alarm) occurs: Replacement surgery should be scheduled as soon as possible. In the case of premature Elective Replacement Indicator, the minimum timeframe of 90 days between Elective Replacement Indicator and End of Service may be reduced due to this battery issue. The date for scheduled replacement of the pump that is displayed on the Model 8840 N'Vision clinician programmer may not be accurate for those pumps experiencing reduced battery performance. Alternative medical management should be considered if appropriate. Elective Replacement Indicator may be considered premature if it occurs sooner than expected based on implant duration and flow rate.

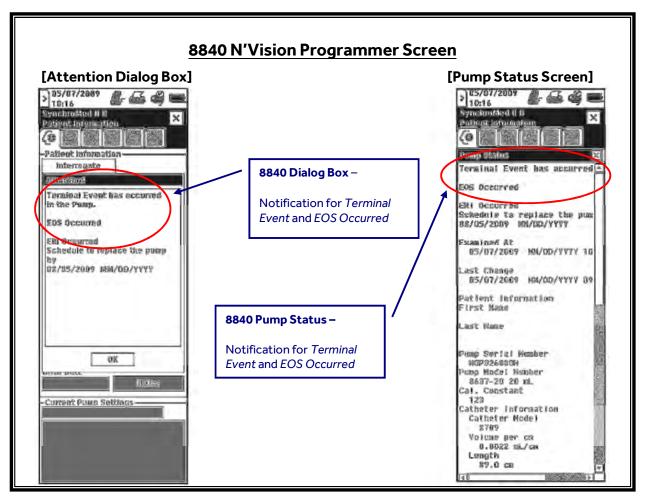
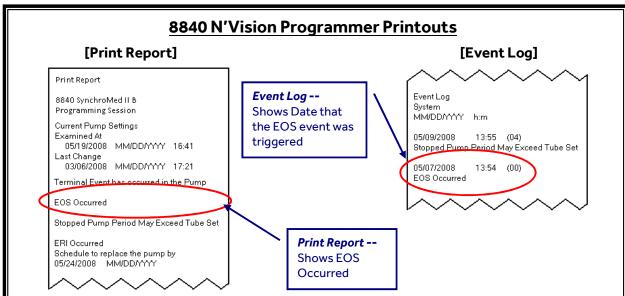
End of Service

At EOS, the pump stops infusing drug. This will result in loss of drug effect and/or potentially drug withdrawal. Telemetry is available until the pump battery is depleted.
