Urgent Field Safety Notice

BVM (Bag-Valve-Mask) Manual Resuscitation Systems

Manufacturer: Intersurgical Ltd

FSCA-identifier: 170124

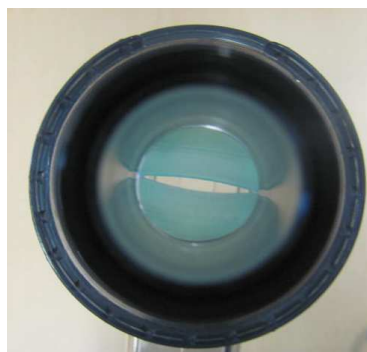
Picture 3: Open valve

1. Ensure the valve opens prior to use when squeezing the resuscitation bag (Picture 1).
2. If the valve is stuck (Picture 2), squeeze the bag fast and firmly to open the valve (Picture 3).
3. If the BVM Manual Resuscitation System contains a pressure relief valve (Picture 1) manually hold this closed to prevent it from opening when squeezing the bag. Repeat action 2 whilst the pressure relief valve function is overridden.
4. Make sure the valve is now open and fully functional prior to use.
