URGENT - Field Safety Notification Medical Device Correction

Philips HeartStart MRx Monitor/Defibrillator on exceptionally rare occasions may exhibit abnormal behavior when operating using a single battery as the sole source of power.

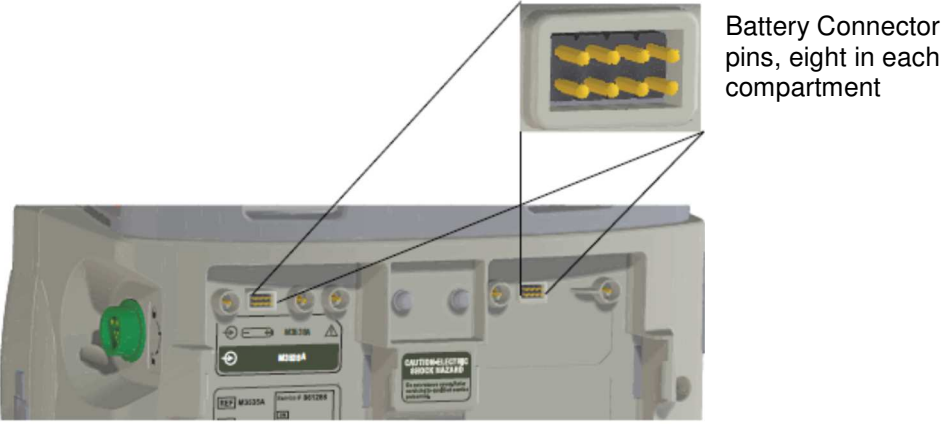
<p>BEHAVIOR DESCRIPTION 1</p>	<p>If the battery connecting pins (in the battery compartment of the HeartStart MRx Monitor/Defibrillator) become damaged or contaminated, it could result in a poor electrical connection that may cause the MRx to either (i) not power on or (ii) repetitively reboot, when used on battery power only.</p>
<p>HAZARD INVOLVED 1</p>	<p>HeartStart MRx Monitor/Defibrillator may, on exceptionally rare occasions, either (i) not power on or (ii) repetitively reboot. Either situation would make the device inoperative, delaying therapy to a patient in need of defibrillation, cardioversion, pacing, or monitoring.</p>
<p>ACTION TO BE TAKEN BY CUSTOMER / USER – 1</p>	<p>When inspecting the device, inspect the HeartStart MRx battery compartment connections. Include this step as part of a routine Operational Check to verify that the battery connector pins are clean, fully extended, not bent, and without residue.</p> <p>Figure A: Battery Connector Pins</p>

<p>Battery Connector pins, eight in each compartment</p>

<p>ACTIONS PLANNED BY PHILIPS - 1</p>	<p>Philips is voluntarily initiating this correction and is providing an Instructions for Use (IFU) Addendum entitled, <u>HeartStart MRx Battery Connector Pins</u>, for all customers with affected units.</p>

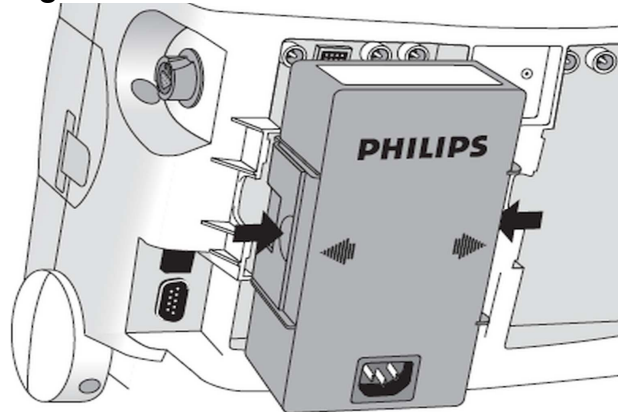
Figure C: AC Module Removal

- a. Remove the AC module from the MRx, rather than unplugging the cord from AC mains (see Figure C).

There are two ways to prevent this power switching. The user can either:

- b. Turn on the MRx using the rotary knob and allow it to complete the start-up before unplugging the device from AC mains.
