URGENT FIELD SAFETY NOTICE

Product Name: **Alaris™ GS, GH, CC, TIVA, PK, Enteral Syringe Pump**

Product Name: **Asena™ GS, GH, CC, TIVA, PK Syringe Pumps**

FSCA Identifier: **RA-2017-02-02**

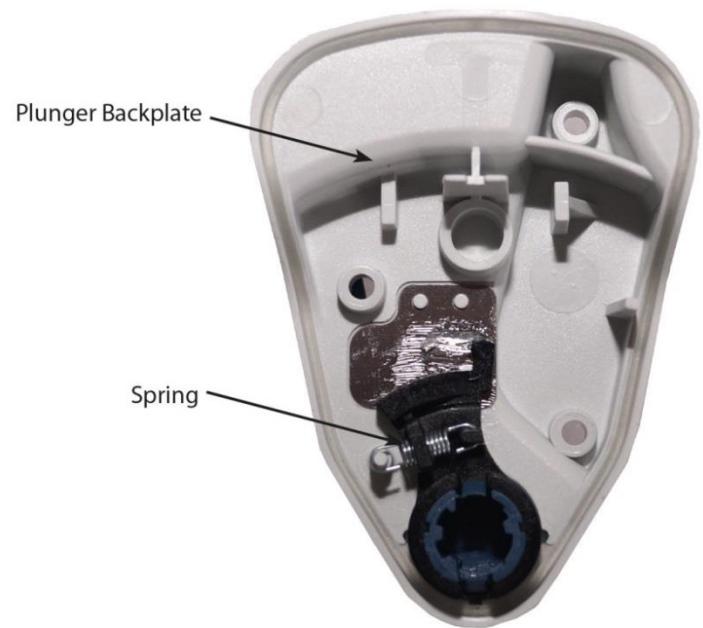
4. Remove the spring from the plunger backplate.
5. Fit a new spring to the plunger backplate.
6. Refit the plunger backplate.
7. Fit the three screws into the plunger backplate.

A kit of 10 replacement springs is available, part number 1000SP01589.
