Urgent Field Safety Notice

Device:
BVM (Bag-Valve-Mask) Manual Resuscitation Systems

FSCA-identifier: 170124 **Date:** 05 June 2017

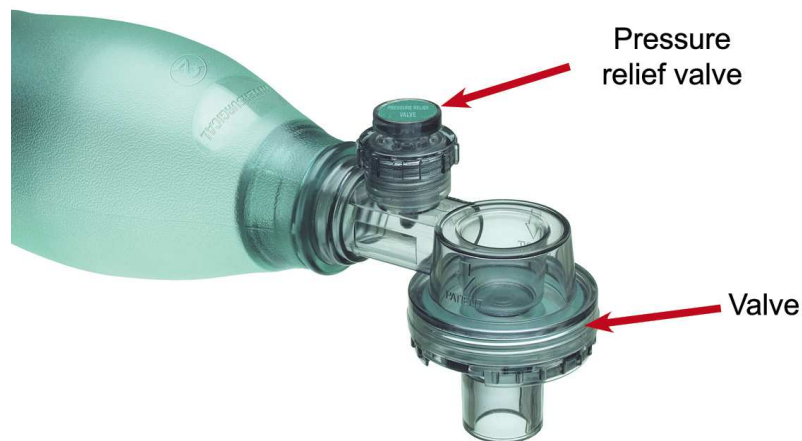
Picture 1: Position of valve and pressure relief valve if included in the system

1. Ensure the valve opens prior to use when squeezing the resuscitation bag (Picture 1).
2. If the valve is stuck (Picture 2), squeeze the bag fast and firmly to open the valve (Picture 3).
3. If the BVM Manual Resuscitation System contains a pressure relief valve (Picture 1) manually hold this closed to prevent it from opening when squeezing the bag. Repeat action 2 whilst the pressure relief valve function is overridden.
4. Make sure the valve is now open and fully functional prior to use.
